REPORT NO: MT-12/337-A

## TYPE LOAD TESTING OF AN R & S FRP ECOLIGHT COVER

CLIENT: **ROAD SAFETY GRATING (R & S GRATING)**  
ATT: JAY RULE  
13 HEALEY ROAD  
DANDENONG SOUTH VIC 3175

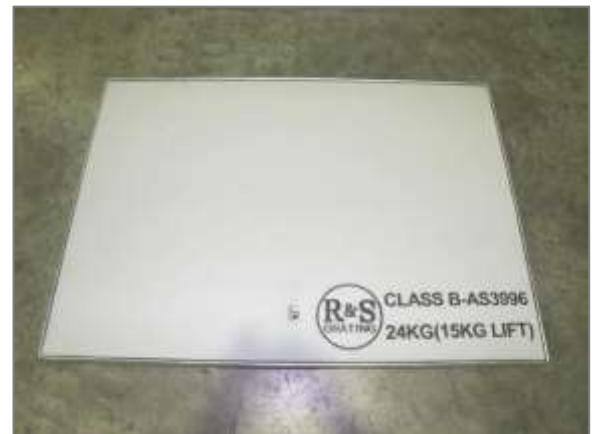
A *Class B*, composite, rectangular cover, measuring 765mm x 1085mm x 47mm, was delivered to the MTS laboratory for Type Load testing and destructive testing (see Fig.1). The client provided the following identification details:

**FIG. 1**  
**COVER TEST ITEM**

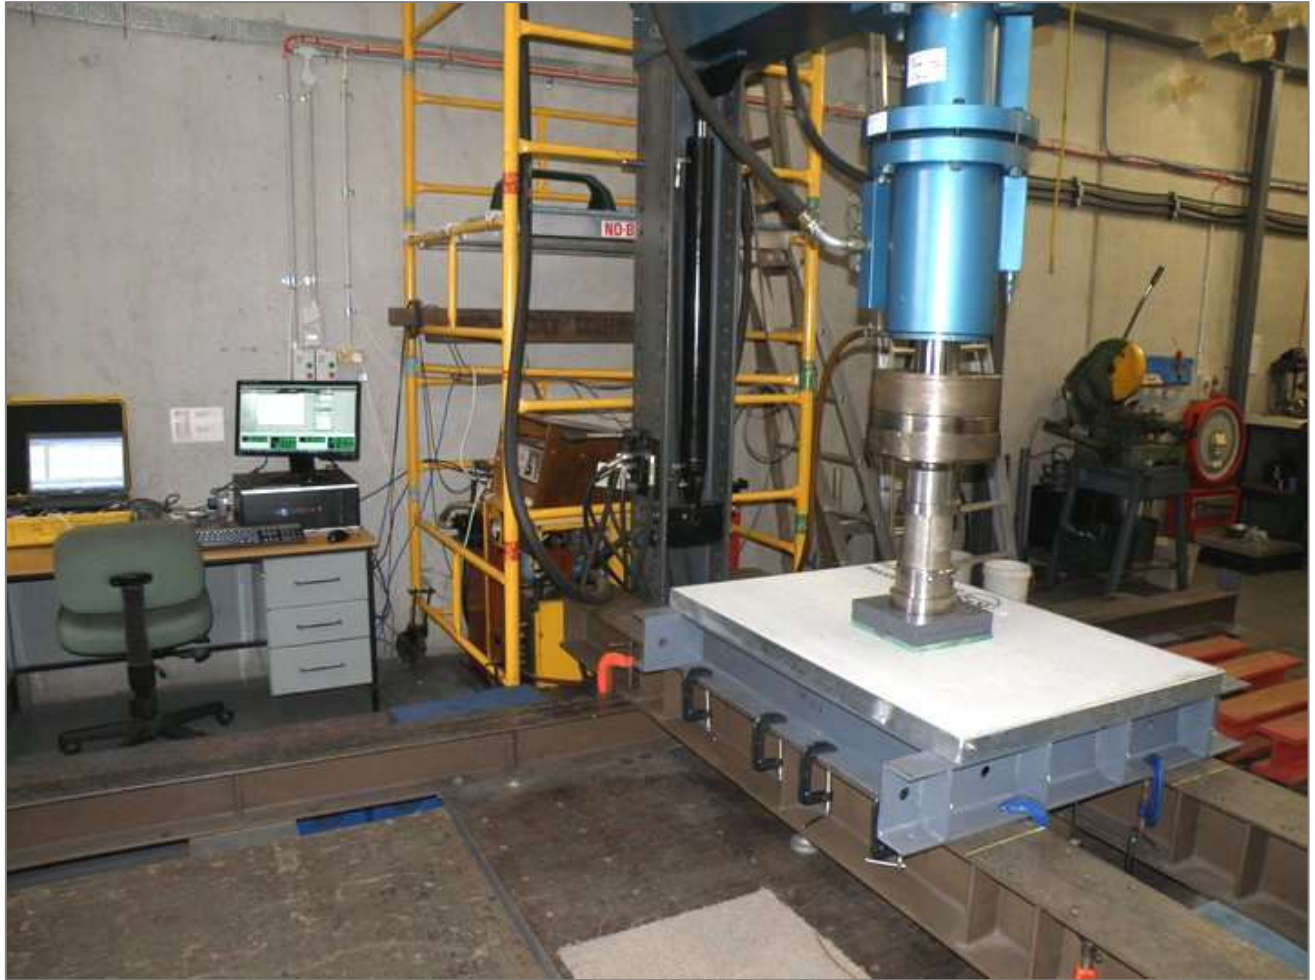
The cover, in its frame, was placed under the actuator of a calibrated testing machine and supported on a rigid steel frame in a manner to mimic the bearing conditions that would normally be provided by the supporting perimeter of a frame (see Fig.2).

A compressive test load was applied vertically to the centre of the cover via a loading platen with a minimum of 25mm clearance to the unobstructed opening. As requested by the client, the rate of loading was 2kN/s. A displacement transducer was positioned underneath on the centre of the cover which was in-turn connected to an electronic data acquisition system used to autographically record deflection throughout testing.

**Fig. 2**  
**COVER LOAD TEST SEP UP**

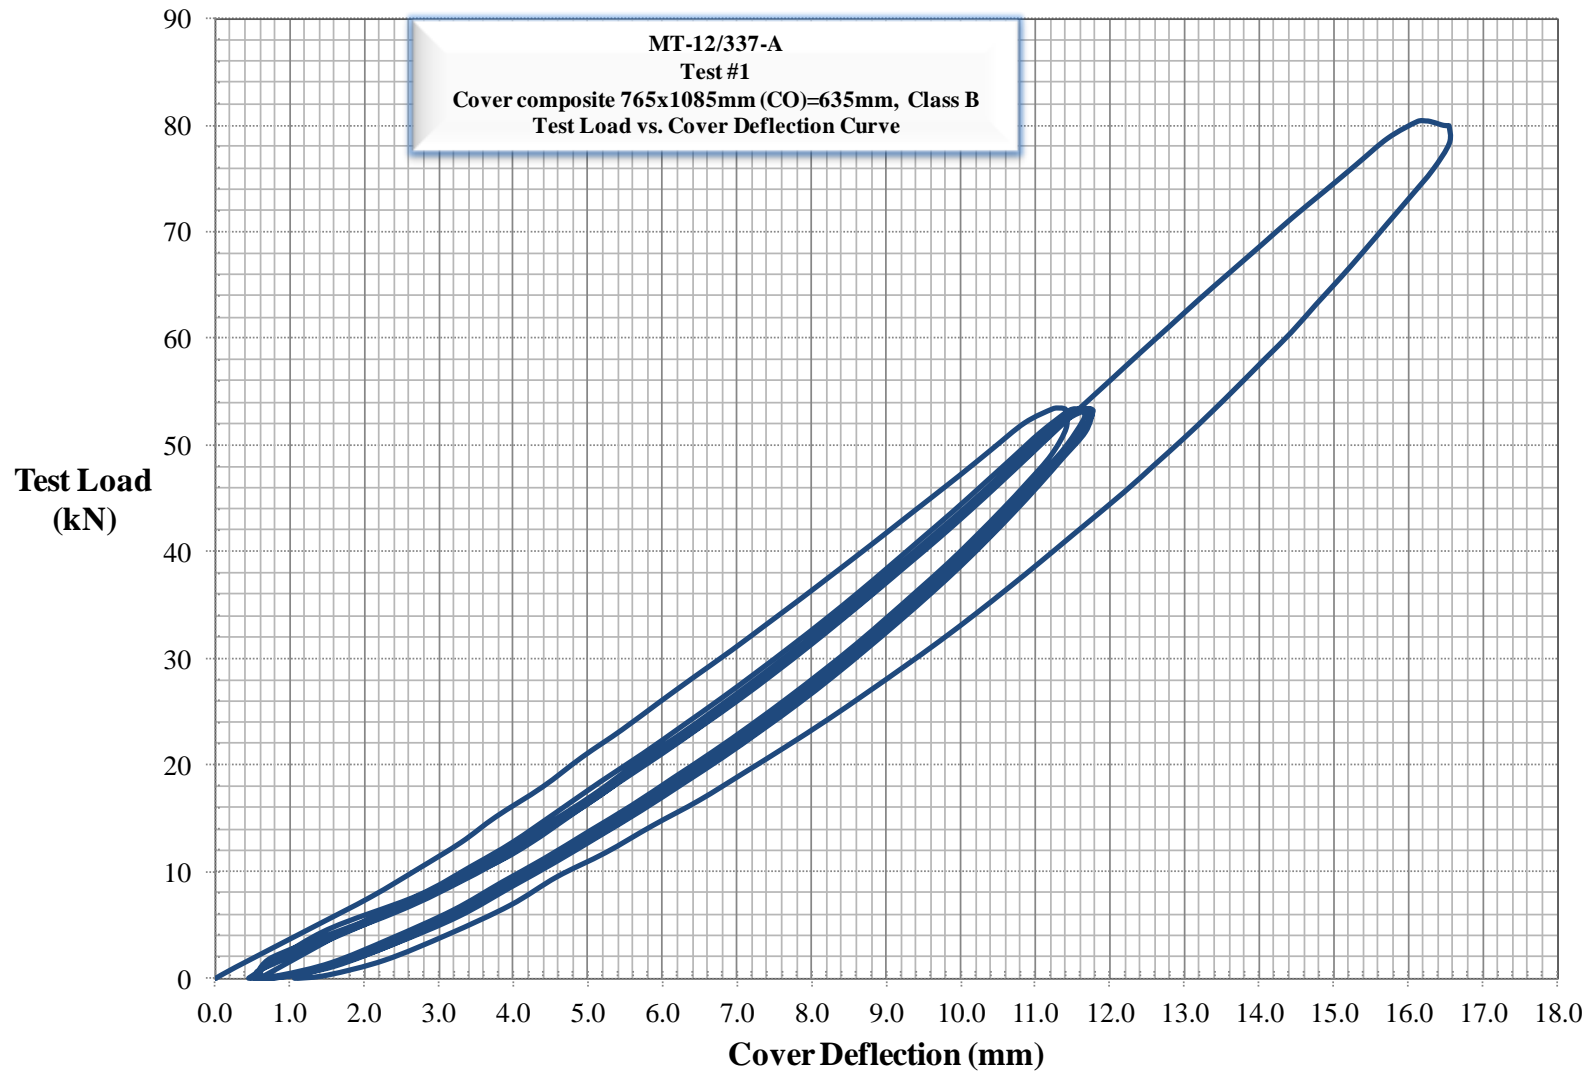
**APPENDIX A1**

Test curves for “Test Load vs. Cover Deflection” and “Test Load vs. Test Time” are provided in Appendix A.
